Staff Investigation Report

Consumers Energy Company - Ray Compressor Station Fire

Incident Date: January 30, 2019

Report Date: January 31, 2020

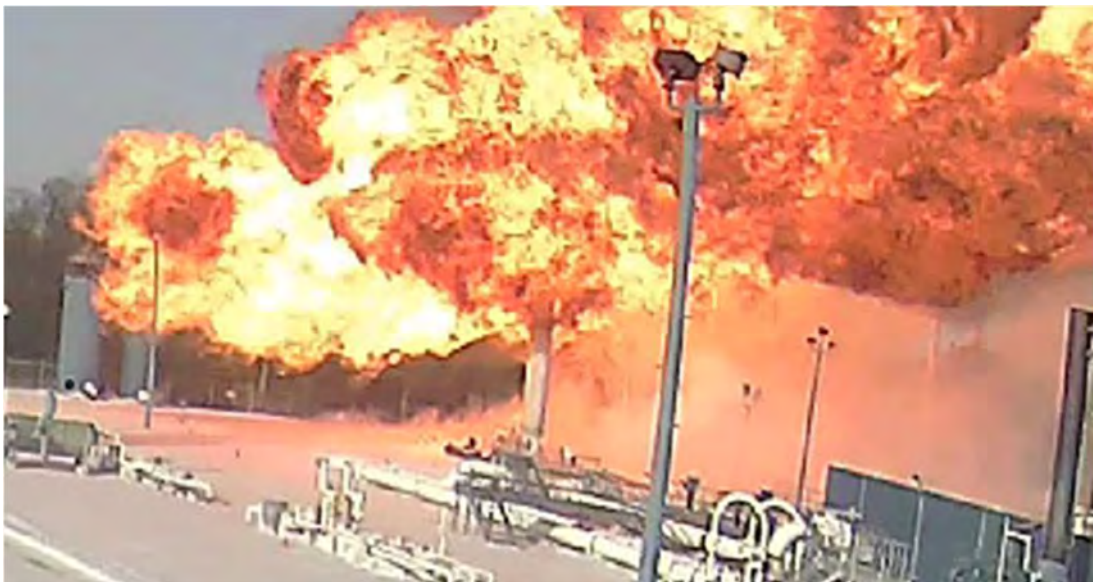
Staff arrived onsite to perform an investigation at 1:21 p.m. on January 30, 2019. The fire was still burning and appeared to be in the area of the Plant 2 dehydration equipment as observed from the headquarters building. Firefighters were onsite and waiting for the gas flow to stop before they were cleared to extinguish what remained of the fire. The fire was being fueled with the natural gas venting from the compressor station piping as a result of the ESD activation, and Consumers had been unable to get close enough to determine the actual failure location. Consumers stated that gas was continuing to enter the system and vent out the blowdown silencers, fueling the fire.

Figure 1: Fire Above Plant 2 Dehydration System

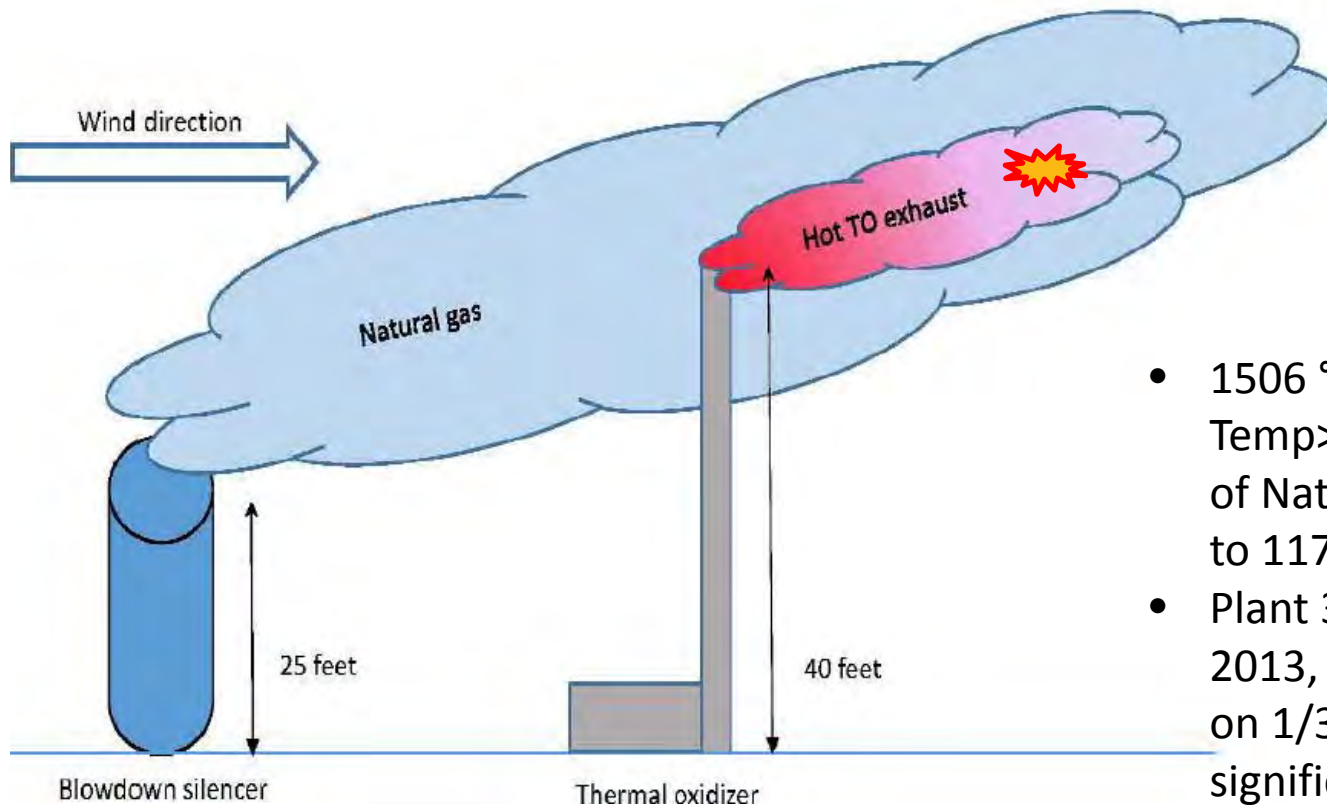
- 1506 °F Thermal Oxidizer Exhaust Temp > Auto Ignition Temperature of Natural Gas ranges from 900°F to 1170°F.
- Plant 3 was commissioned in 2013, and the event that occurred on 1/30/19 happened with significant wind directing the gas plume towards Plant 2 Thermal Oxidizer while in operation.

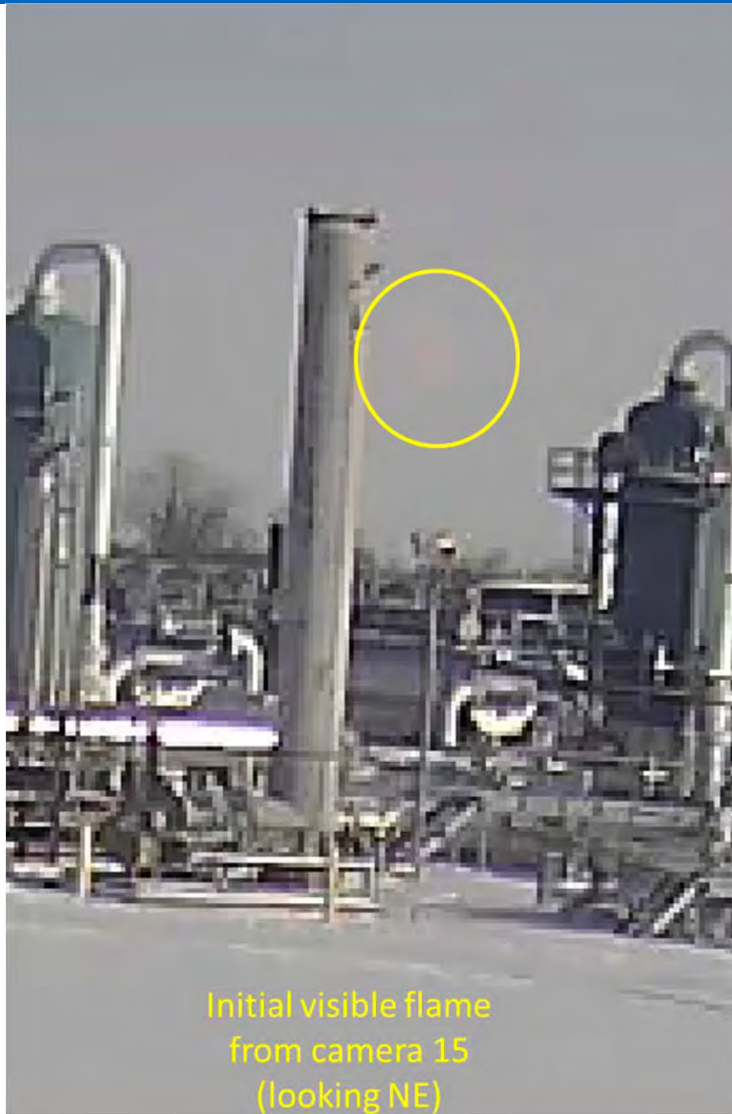
Initial visible flame
from camera 15
(looking NE)

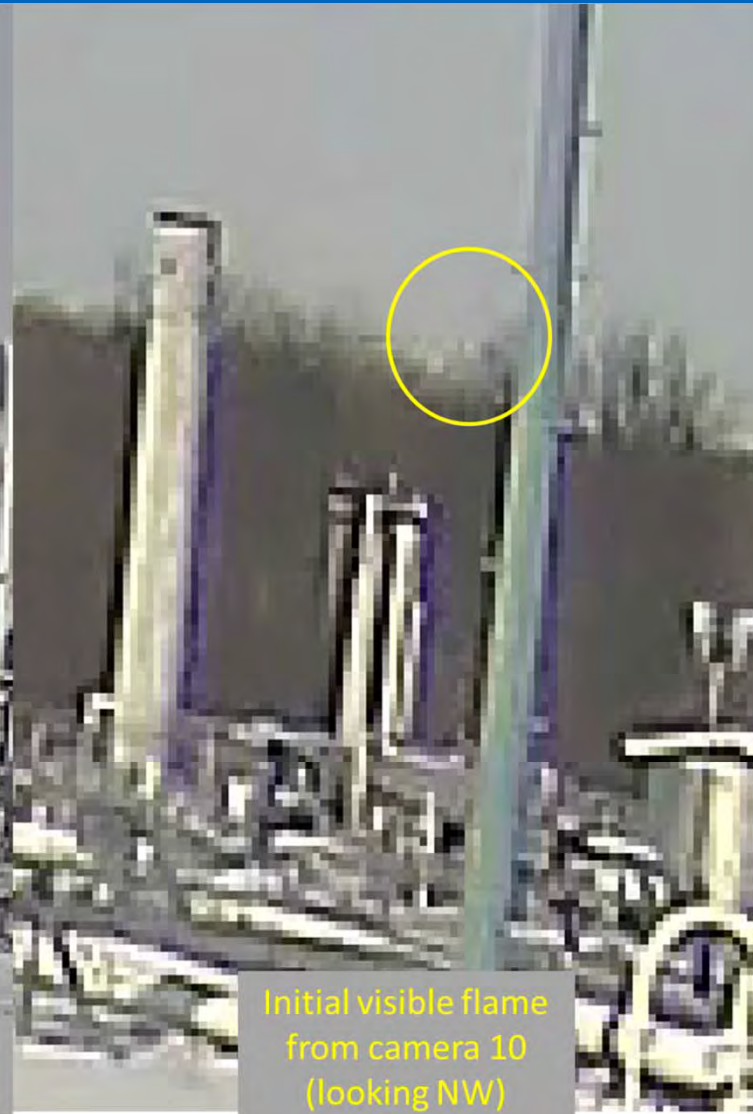
Initial visible flame
from camera 10
(looking NW)

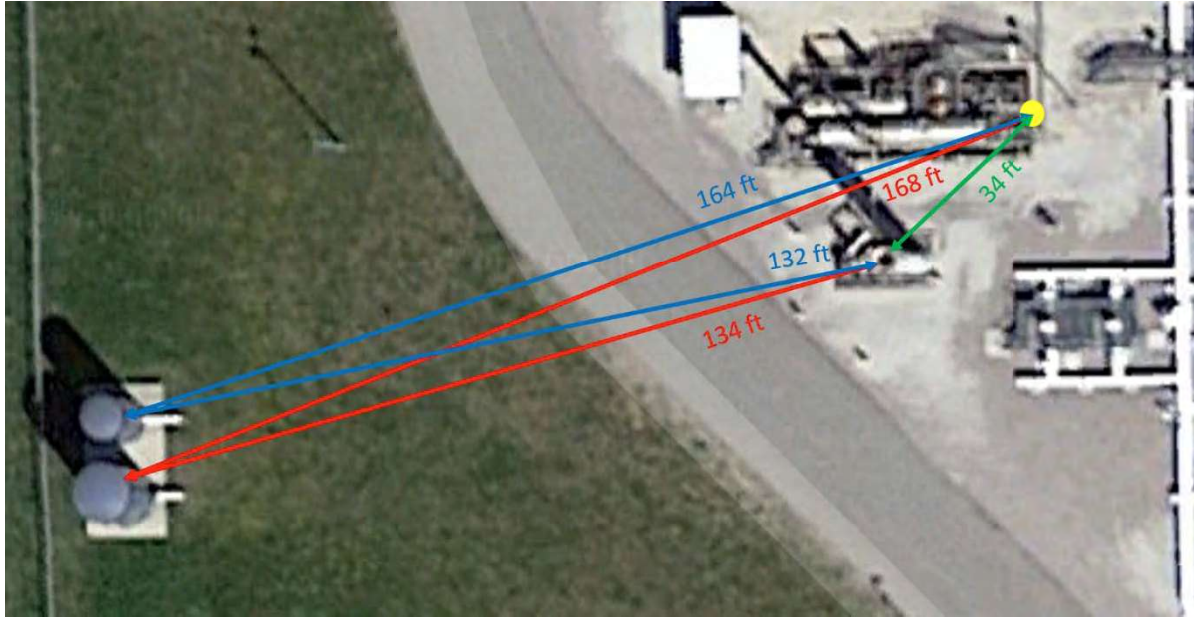
Figure 3. Location of first observed flame based on analysis of surveillance video

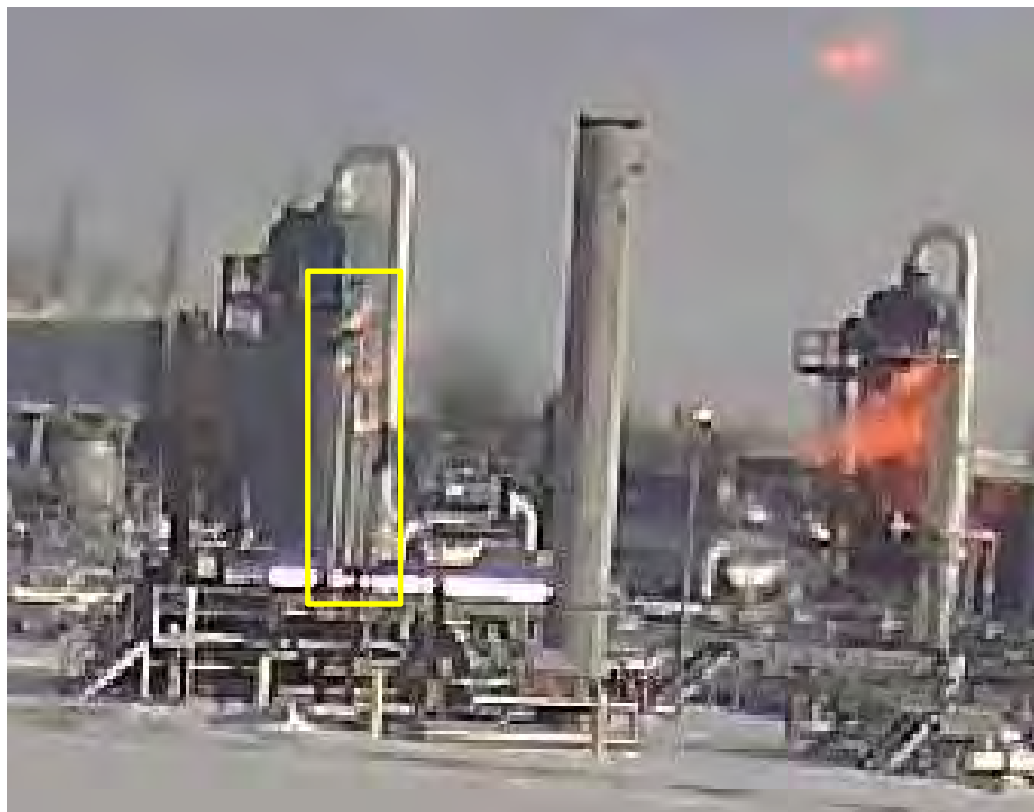
Surveillance Camera 10, 10:26:12 (cropped)

thermal oxidizer, and both rely on natural gas as a fuel gas. However, there was no evidence to suggest an ongoing release of natural gas or waste gas from either piece of equipment. There was no observed flame at the base of this equipment, where the natural gas was fed. The Plant 2 reboiler showed minimal signs of fire and/or heat damage, primarily on the elevated portions and in the area facing the Plant 3 blowdown silencers. Approximately 20 seconds after the first observed ignition, fire was visible in the vicinity of waste gas piping from the Plant 2 reboiler to the Plant 2 thermal oxidizer (see Figure 4). However, the fire was concentrated around the waste gas relief valve and two apparently-closed valves (c.f., Figure 5). It is more likely than not that these appurtenances appeared to be on fire due to the turbulence generated as the natural gas blowdown traveled past them. Thus, ignition hypotheses involving fuel sources associated with the Plant 2 process equipment were refuted.

Figure 4. Reboiler Still Column (in yellow box).

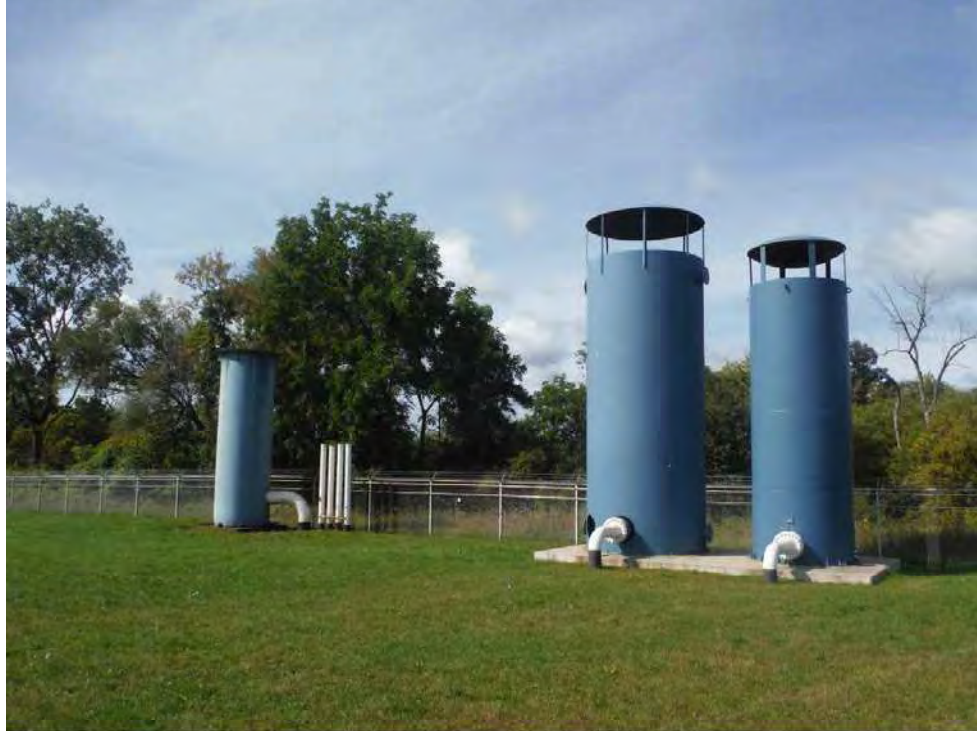
Figure 9. Silencers for Plant 3 (two right hand side stacks) and Plant 2 (large stack on the left) in their pre-fire condition.

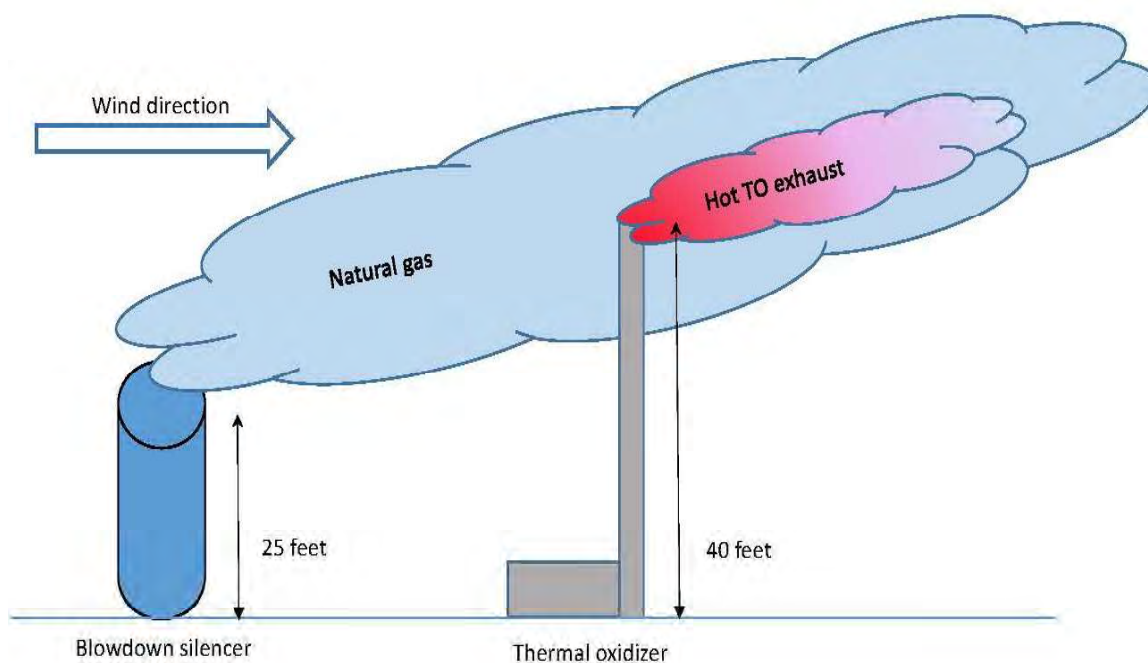
An important factor in the ignition of the natural gas discharge was that the elevation of the thermal oxidizer stack was 15 to 17 feet taller than the blowdown silencers. The buoyancy of the natural gas discharge would tend to cause the blowdown jet to rise. The hot exhaust from the thermal oxidizer was ideally positioned (given the prevailing wind direction) to inject hot gas into the dispersing natural gas cloud, and conversely, to entrain natural gas into the hot thermal oxidizer exhaust. This scenario is depicted in Figure 14.

Figure 14. Schematic illustrating the intersection of the Suction blowdown jet with the thermal oxidizer jet.

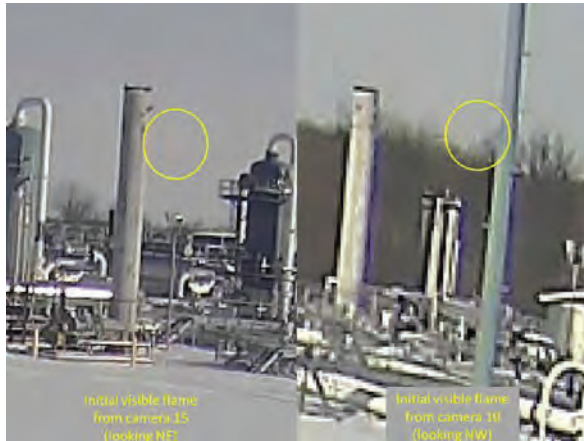
The blowdown gas vented through the silencers located at the southwest corner of the station property. This blowdown gas ignited. The wind pushed the flames north eastward. The first visible sign of fire was observed near the Plant 2 thermal oxidizer stack at 10:25:51 a.m. The fire increased in size and reached the top of the Plant 3 blowdown silencer by 10:26:22 a.m. (see figures 3 and 4)

Figure 3. Initial visible flame

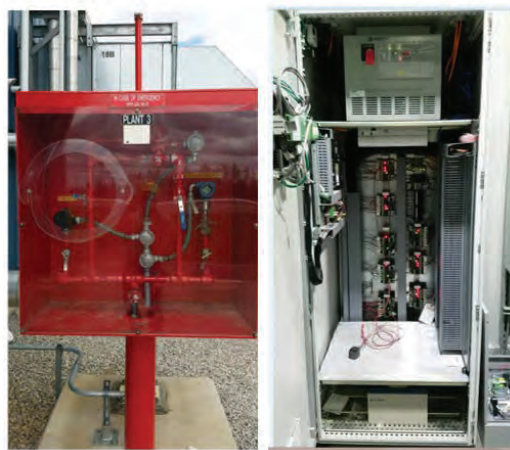
Figure 1. Relocated controls

To eliminate the grounding voltage into the Det-tronics system, the well pump pressure switch and pressure transmitter will be relocated to the east side of the plant 3 auxiliary building (Figure 1). The risk of a communications break-down between the pilot air system and its modules has been mitigated by relocating the modules from the headquarters building to the plant 3 auxiliary building.

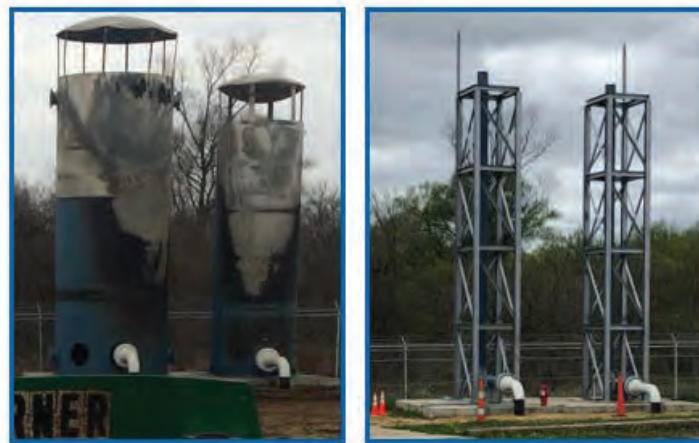
Figure 2. Old and new straight pipe designs

and identifies designs that provide better mitigation. The model revealed a better design for gas dispersion pipes. New straight pipes, which allow gas to exit at a high velocity, have been installed at the Ray Compressor Station (Figure 2) in conformity with this finding. Future gas ejections will reach a higher elevation before mixing with enough air to become combustible. The Company continues to model additional scenarios for analysis and, by year end, will have developed a standard for Plant Hazard Analysis that will apply to all future projects and sites.

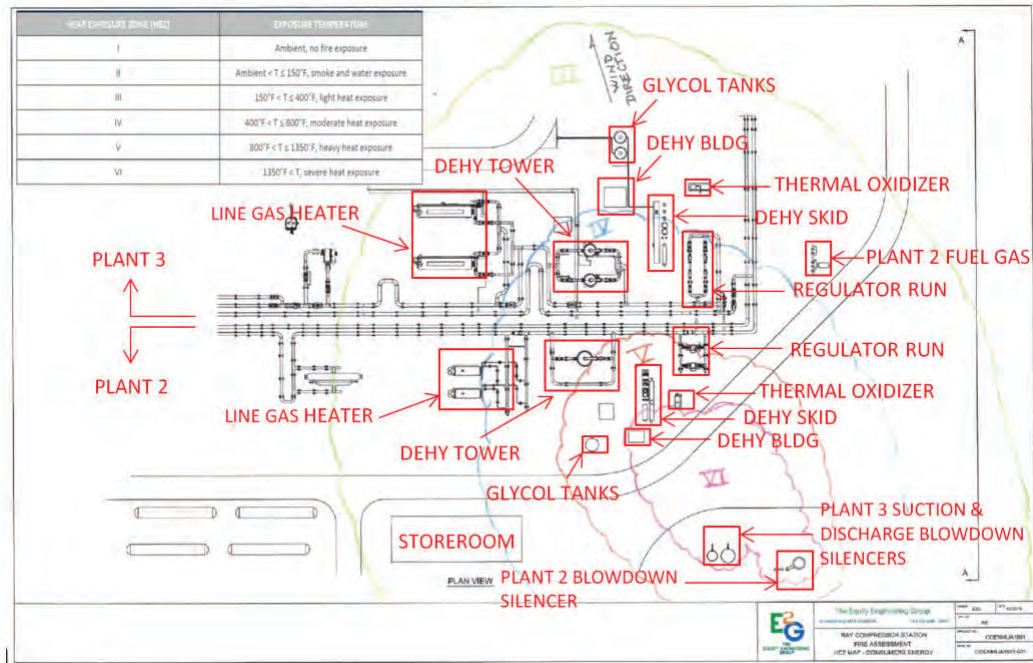
The Company prioritized repairs in early February 2019 and finalized the assessment of the fire damage in May 2019. This process revealed that the most severely damaged equipment at the Ray facility was in proximity to the Plant 3 blowdown vents and silencers. There was also significant damage to the Plant 2 and 3 dehydration equipment, and moderate damage to those Plants’ injection equipment. Most of the affected areas are illustrated below in Figure 1. Firegate and large bore valve damage also occurred. While not shown in the figure, this equipment is located within the same general vicinity as the other damaged equipment.

Figure 1. Locations of Damaged Equipment at Ray Compressor Station

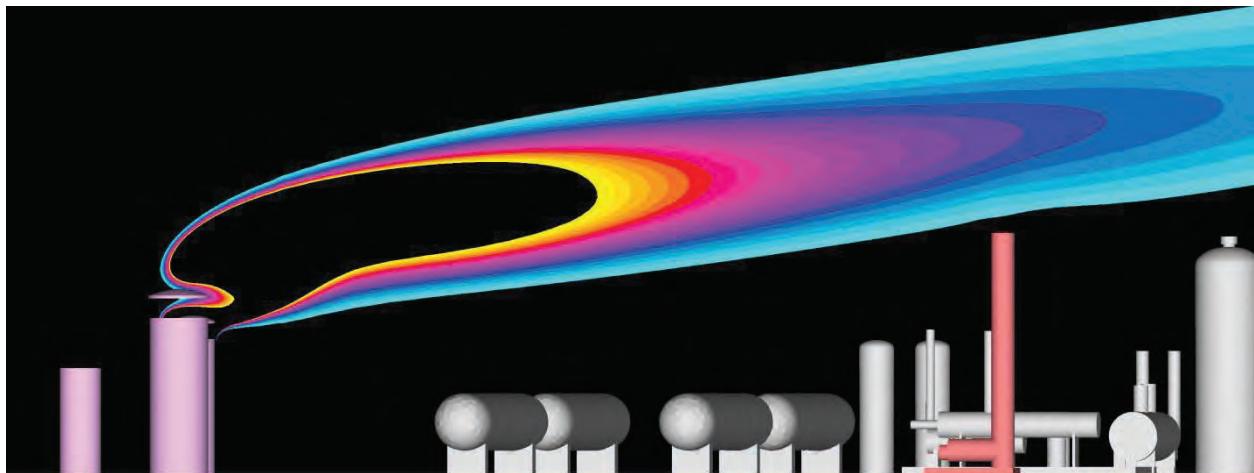
The model was created to simulate the original configuration as well as the new design to validate that a risk for ignition is not present. Figure 1 below shows the conditions present on the day of the fire event. The natural gas in the original configuration included a blowdown with silencers which created a horizontal flow that dispersed the gas over the gas processing equipment based on the wind conditions.

Figure 1. Ray Plant 3 Blowdown 3-1-7 Original Configuration (with silencer)

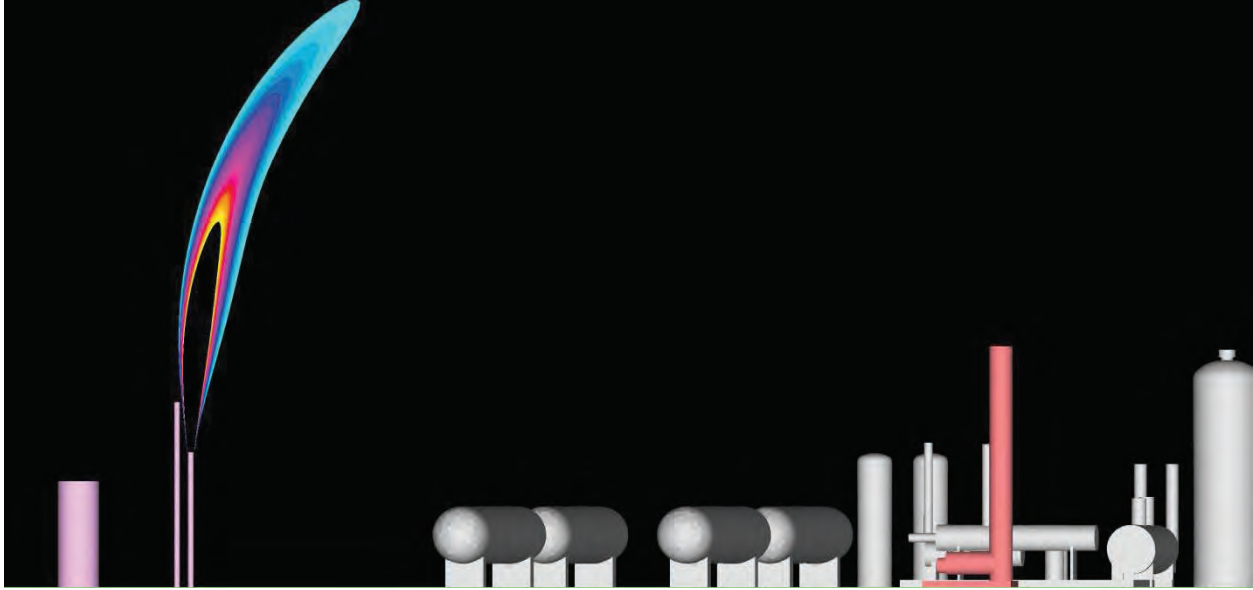
Figure 2. Ray Plant 3 Blowdown 3-1-7 New Configuration (without silencer)

Based on the dispersion modeling results, Consumers Energy installed new blowdown piping that does not include silencers. The removal of these silencers from the design is the primary change allowing the gas to flow vertically. Figure 2 shows a simulation of the new configuration under similar wind conditions as the time of the incident.
