Staff Investigation Report

Consumers Energy Company - Ray Compressor Station Fire

Incident Date: January 30, 2019

Report Date: January 31, 2020

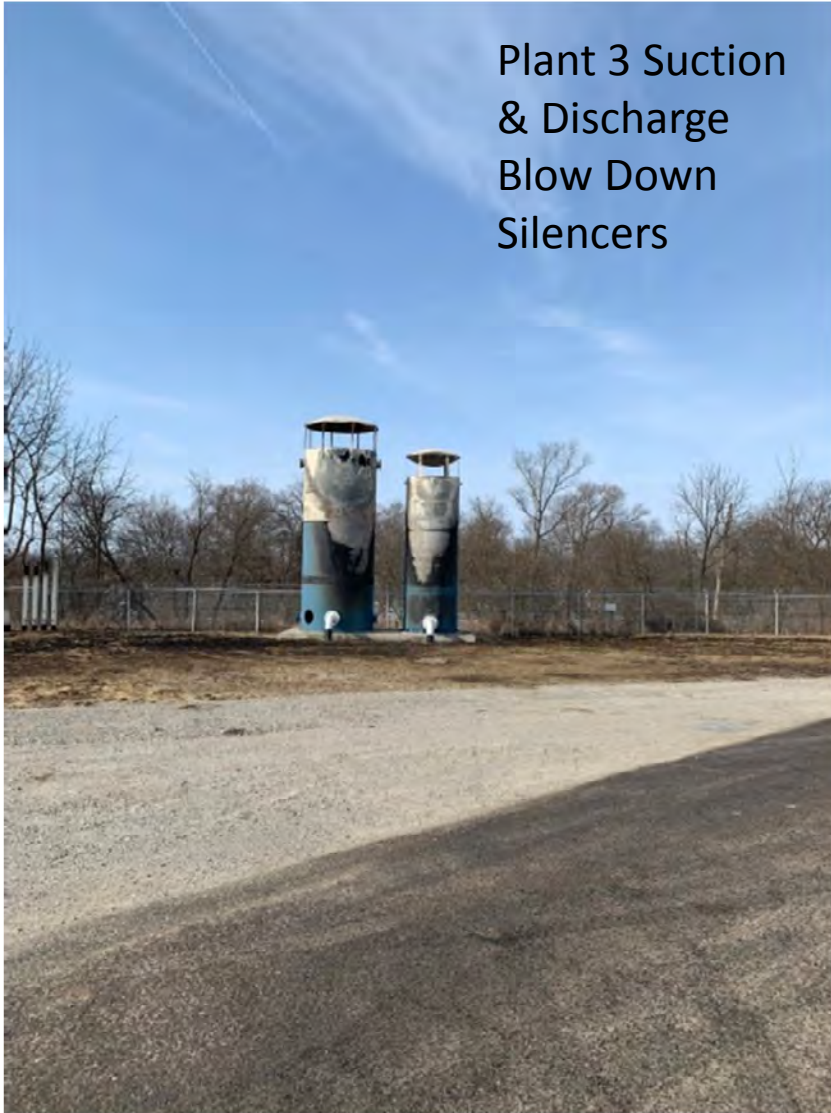
Plant 3 Suction
& Discharge
Blow Down
Silencers

- Direct causal factors for fire
 - Fuel:
 - ◆ Fuel provided by blowdown discharges
 - Oxidizer (air):
 - ◆ Dispersion and mixing with air
 - ◆ Contributing factors: silencer design, wind conditions
 - Ignition source:
 - ◆ Probable ignition source was Plant #2 thermal oxidizer exhaust raising fuel/air mixture above auto-ignition temperature
 - ◆ Contributing factors: elevation and proximity of TO stack relative to silencer stack elevation
- Root Cause
 - Less than adequate (LTA) siting analysis for Plant #3 silencers
 - ◆ Failed to identify flammability hazard associated with blowdown
 - ◆ 49 CFR 192.167(a) (2) requires that discharges of gas during blowdowns “will not create a hazard.”
 - ◆ Plant #3 silencers too close to #2 TO as currently designed

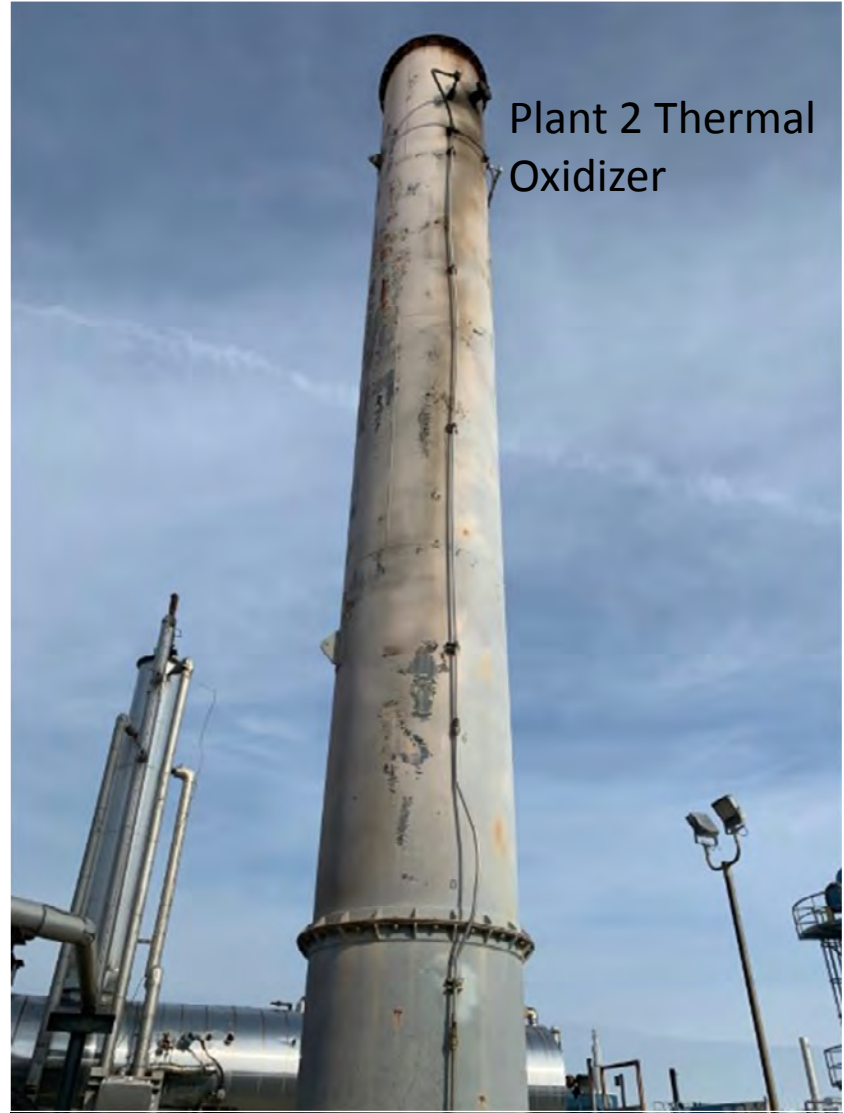
- 1506 °F Thermal Oxidizer Exhaust Temp > Auto Ignition Temperature of Natural Gas ranges from 900°F to 1170°F.
- Plant 3 was commissioned in 2013, and the event that occurred on 1/30/19 happened with significant wind directing the gas plume towards Plant 2 Thermal Oxidizer while in operation.

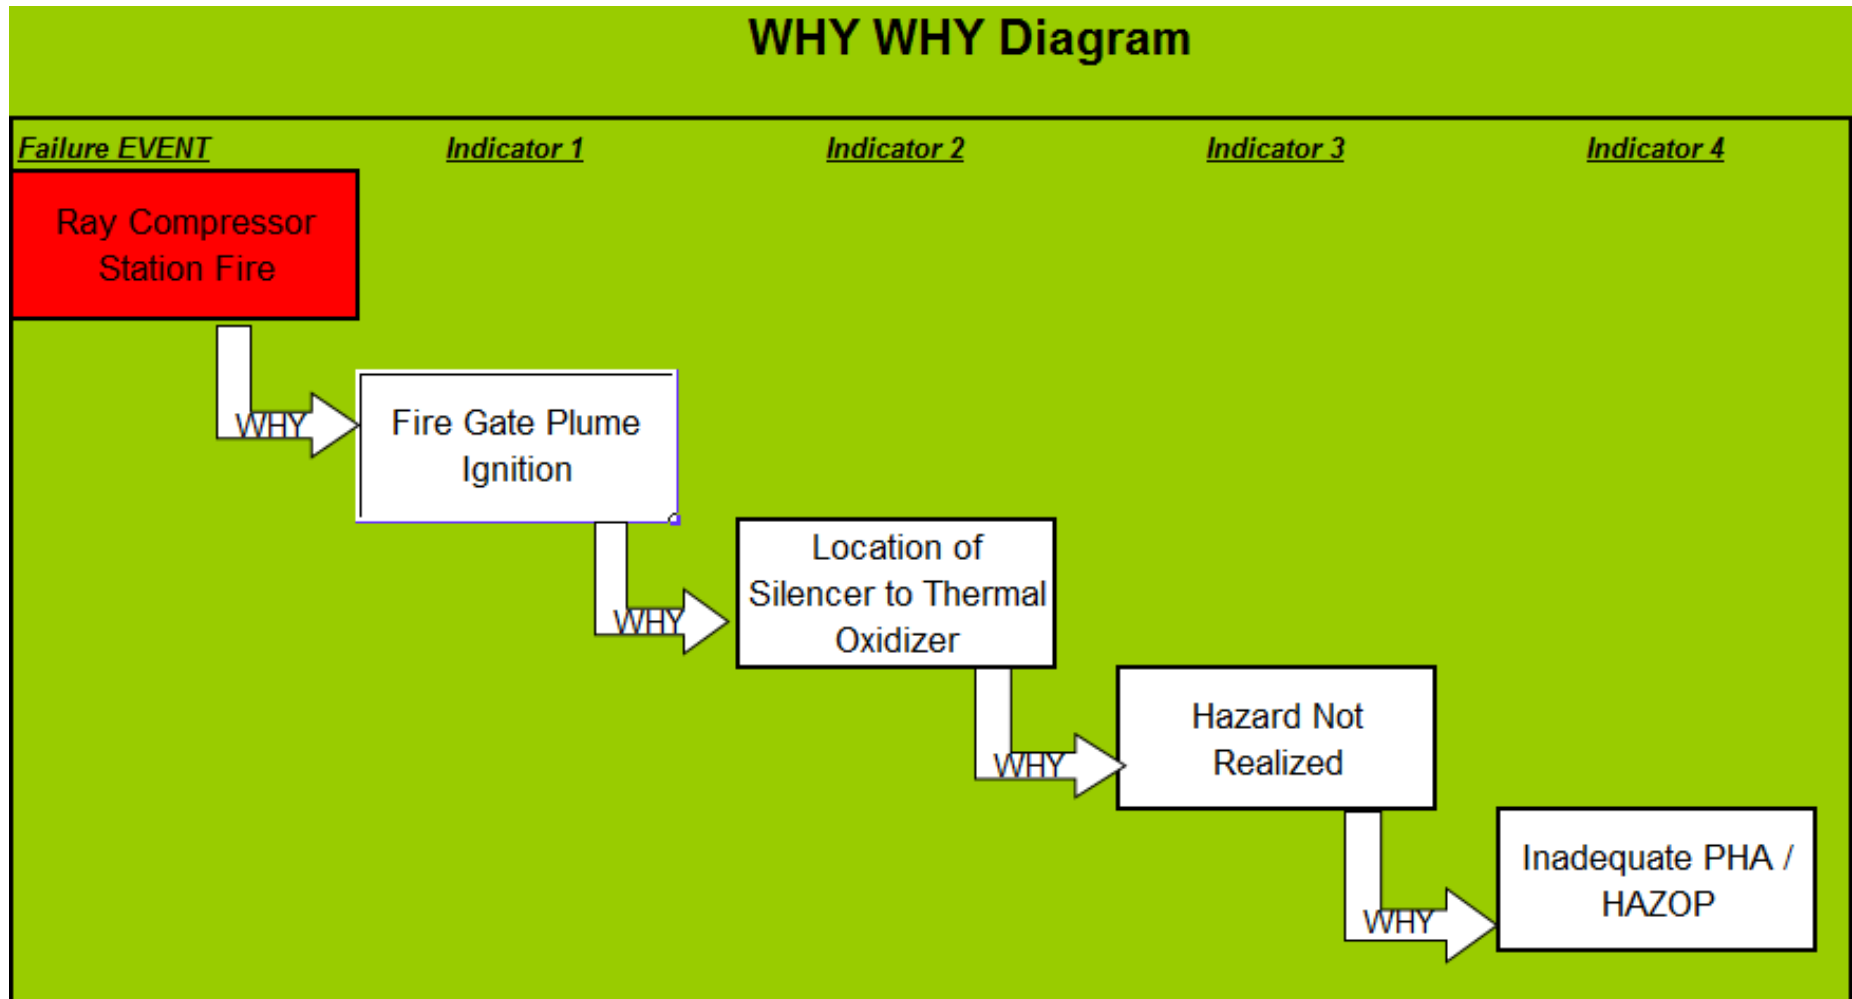
Why Why Diagram

- **Root Cause Components**
 - **Physical Root components:**
 - Ignition source (thermal oxidizer) too close to fuel source (blow down silencers) based on characteristics of blow down silencers and physical location of the equipment.
 - **Human Root components:**
 - Process Hazard Analysis performed by Engineer of Record did not address risk of gas once it left blow down silencers and require gas dispersion model to qualify siting of blow down silencers and/or their required design characteristics.
 - **Systemic Root components:**
 - No CE Process Hazard Analysis standard
 - ◆ No minimum requirements for PHA.

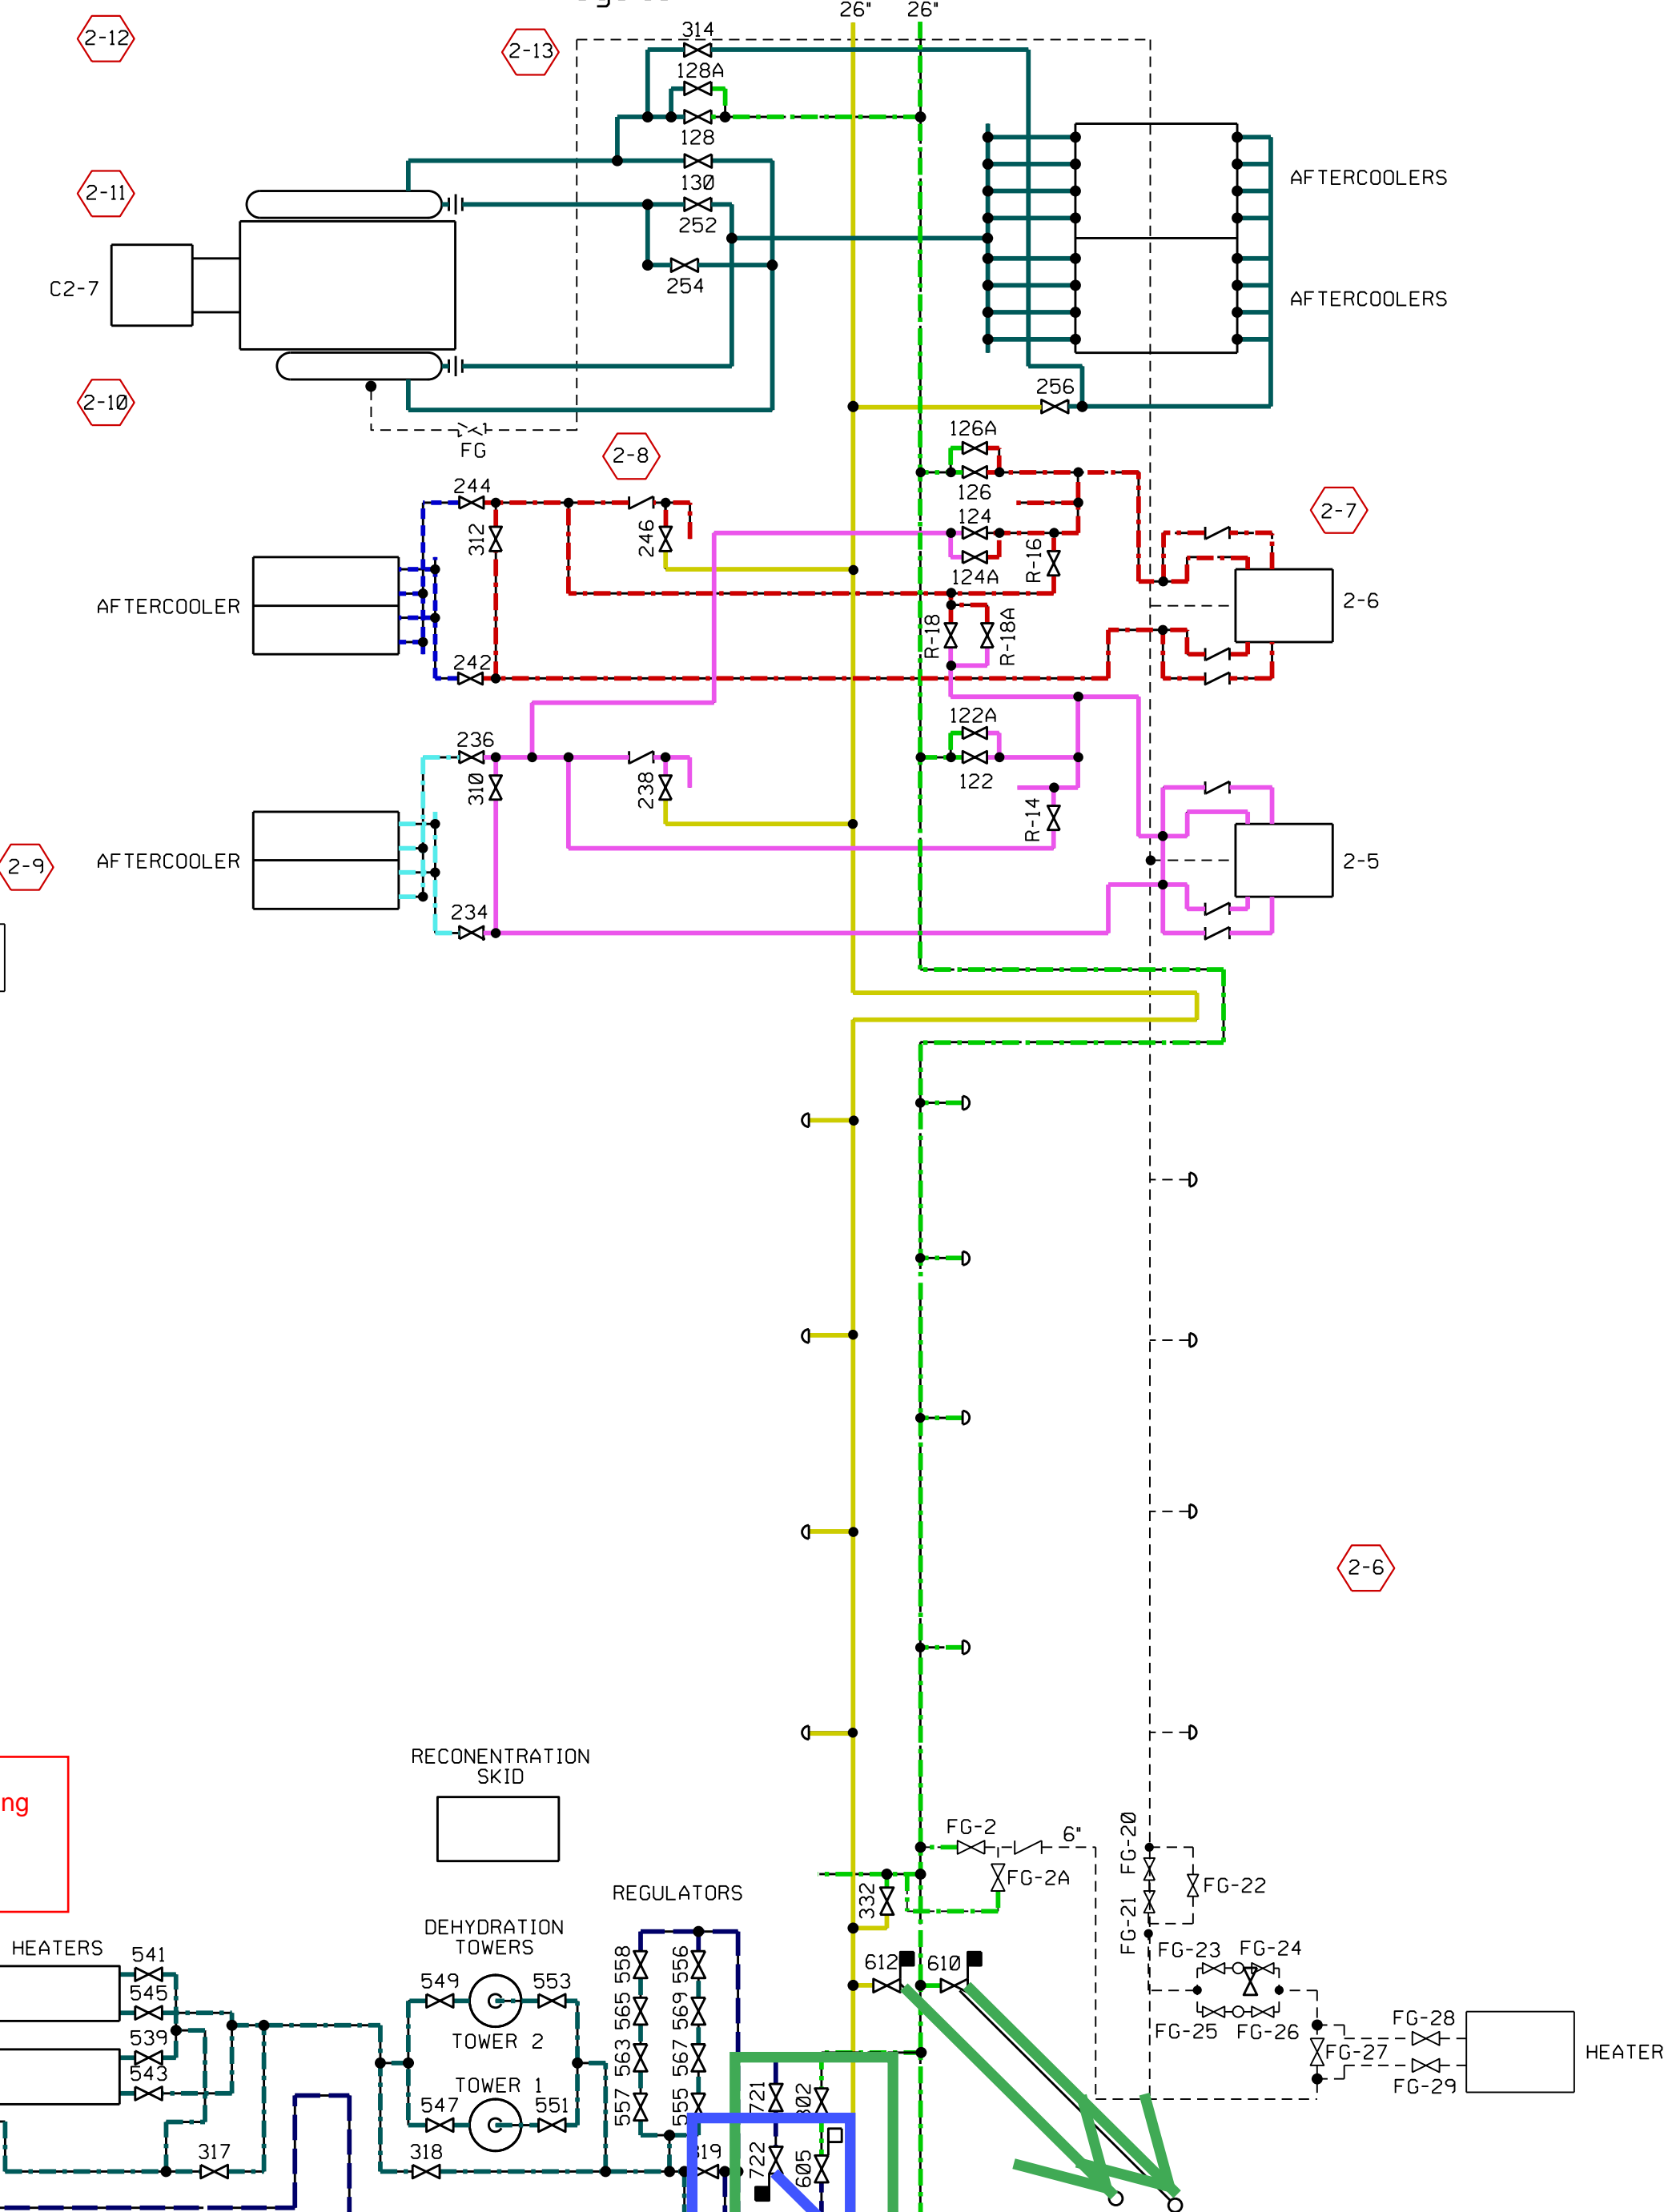
Plant 3 - Firegate Vent valves

Additional gas
vented off during
the firegate
603-607 and
604-608Flow Control valve
R4 and R8 were
closed during
firegate to help
control fuel to the
fire. This trapped
gas in the plant 2
suction area.
Trapped gas 608 to
366/R4/R8RAY
COMPRESSOR STATION
EMERGENCY PLAN A
FIG 1
COVER SHEET
REV 07/07/17
H-3679 SH 1

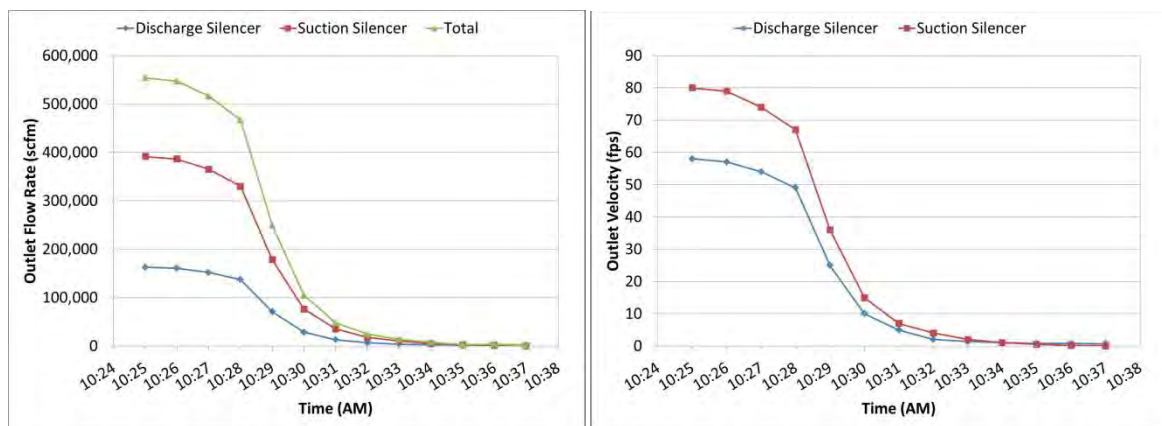
Figure 6. (Left) Calculated flow rate (scfm) for the Plant 3 Suction and Discharge silencers and the total combined flow rate. (Right) Calculated velocity (fps) for the Plant 3 Suction and Discharge silencers.

The release started at a very high flow rate, which produced a large, concentrated cloud of natural gas.

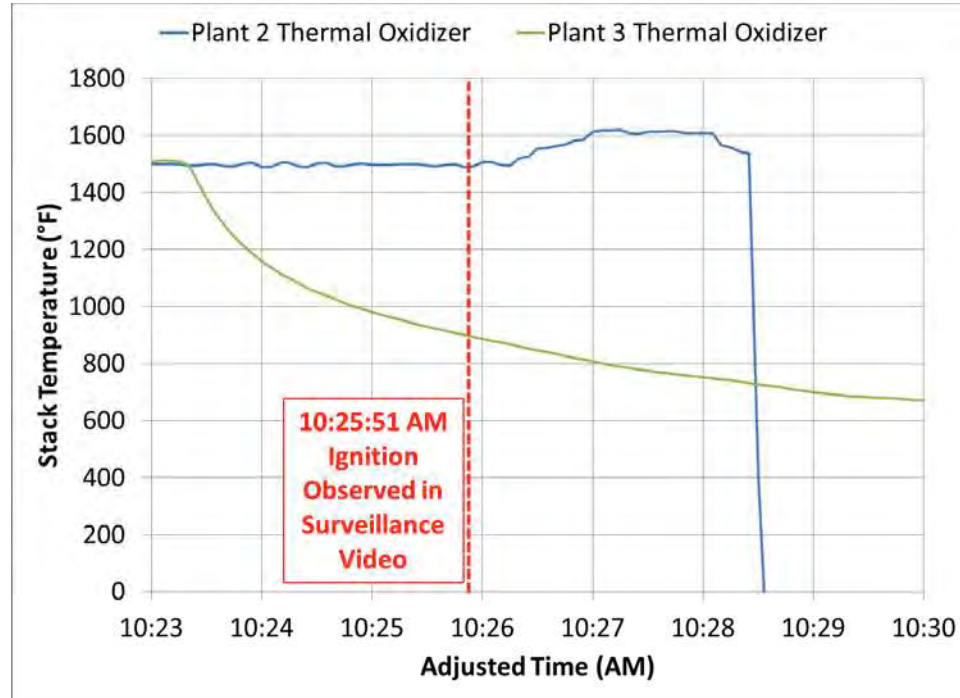
The Plant 3 thermal oxidizer temperature begins to drop shortly after the emergency shutdown of Plant 3 had initiated. The Plant 2 thermal oxidizer temperature data documents a temperature rise consistent with the flame exposure. This temperature rise started shortly after the observation of flames in the surveillance videos. The temperature data are plotted in Figure 12.

Figure 12. Process data for the Plant 2 and Plant 3 Thermal Oxidizers (time adjusted by -50 seconds per RCA team findings).

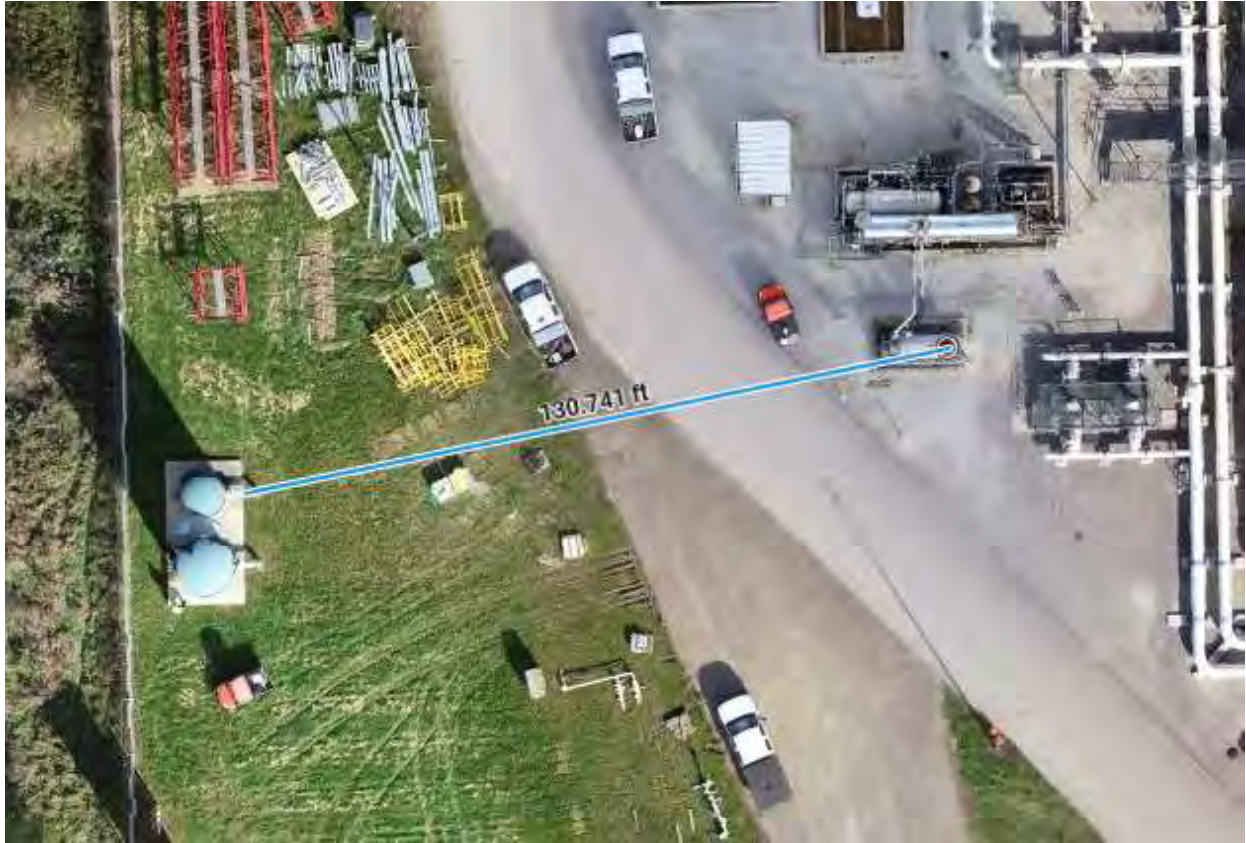
Figure 13. Aerial photograph depicting the compass direction from the blowdown silencers to the Plant 2 thermal oxidizer

The direction of the vector is west-southwest. Thus, the wind was blowing the blowdown discharge almost directly at the Plant 2 thermal oxidizer.

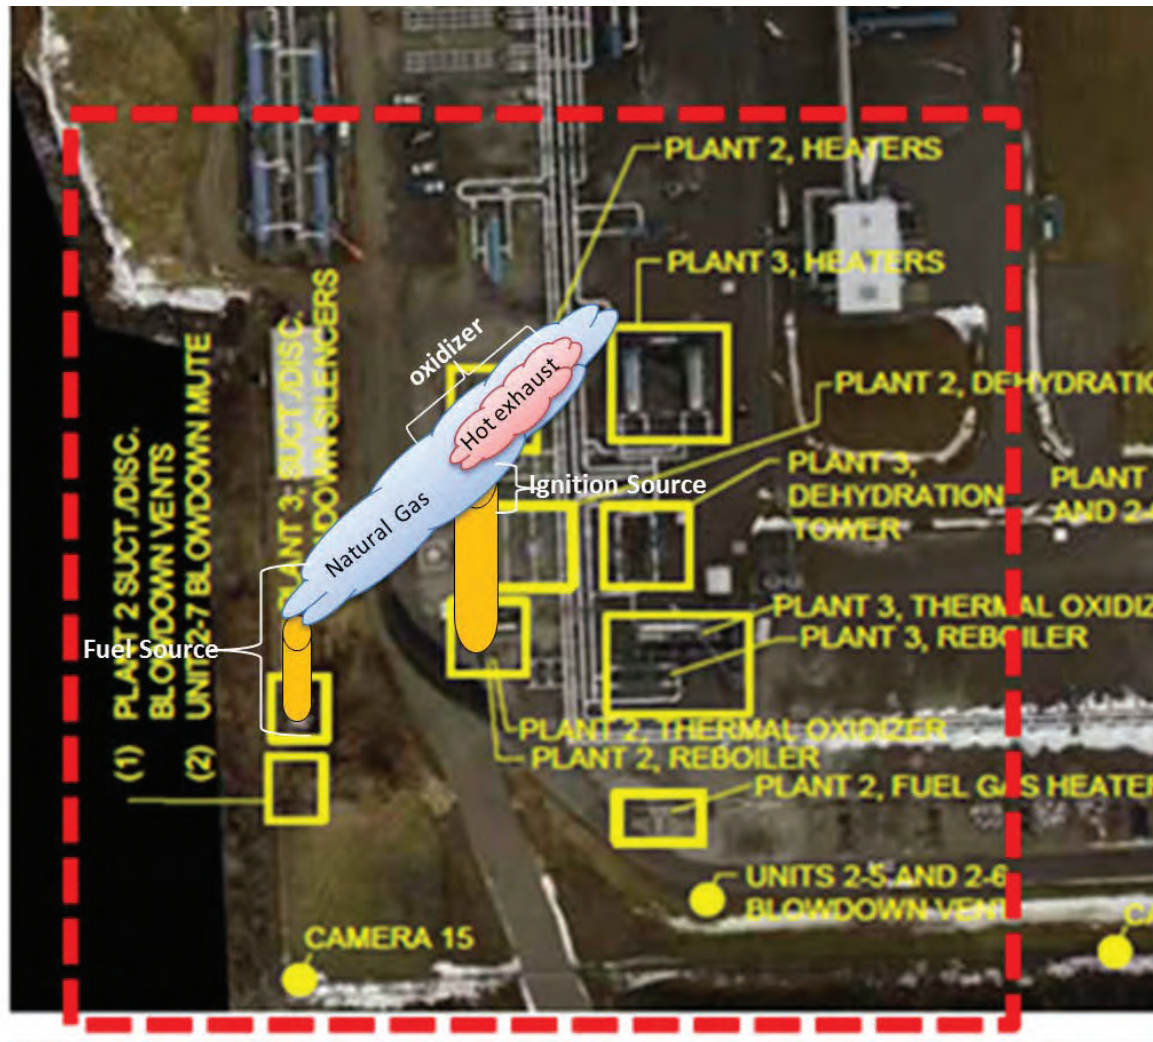
Ignition Source: When the fire-gate occurred, the significant wind directed the gas plume towards the Plant 2 thermal oxidizer (see figure 2). The thermal oxidizer was in operation at the time due to the peak natural gas demands on the system. A thermal oxidizer uses a flame to destroy pollutants from the reboiler. The ignition source was determined to be the Plant 2 thermal oxidizer exhaust which raised the temperature of the plume of natural gas and air mixture above the auto-ignition temperature.

Per National Fire Protection Association (NFPA) 921 Guide for Fire & Explosion Investigations, the auto-ignition temperature of natural gas ranges from 900 degrees F to 1,170 degrees F. Natural gas will auto-ignite at or above this range. At the time of ignition, the Plant 2 thermal oxidizer's exit temperature was 1,506 degrees F per thermocouple historian data. The thermal oxidizer's exhaust temperature was greater than the auto-ignition temperature of natural gas, making the exhaust a competent ignition source.

Figure 2. Illustration of ignition elements

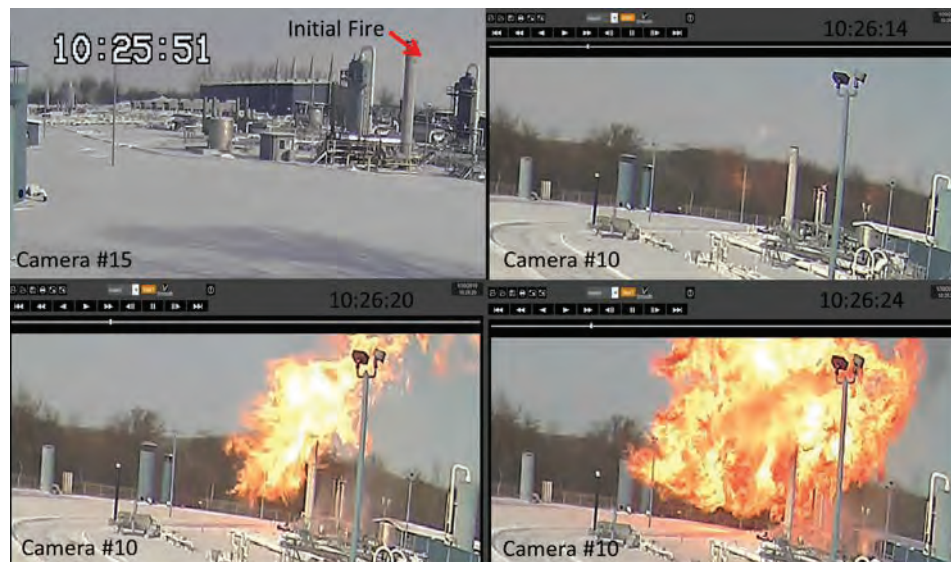
Personnel at the Ray Plant manually fire-gated Plant 1 and Plant 2, as part of our standard safety protocols, at 10:27:58 a.m. and 10:28:22 a.m., respectively. At 10:28:48 a.m., there was a second ignition at the Plant 2 vent stack, which is located next to Plant 3's blowdown silencers and is the location where the natural gas is released for Plant 2 (see figure 5). The flames extinguished when the natural gas was completely vented. The fire department arrived on scene at 10:38 a.m. and left at 3:34 p.m.

Figure 5. Progression of the fire

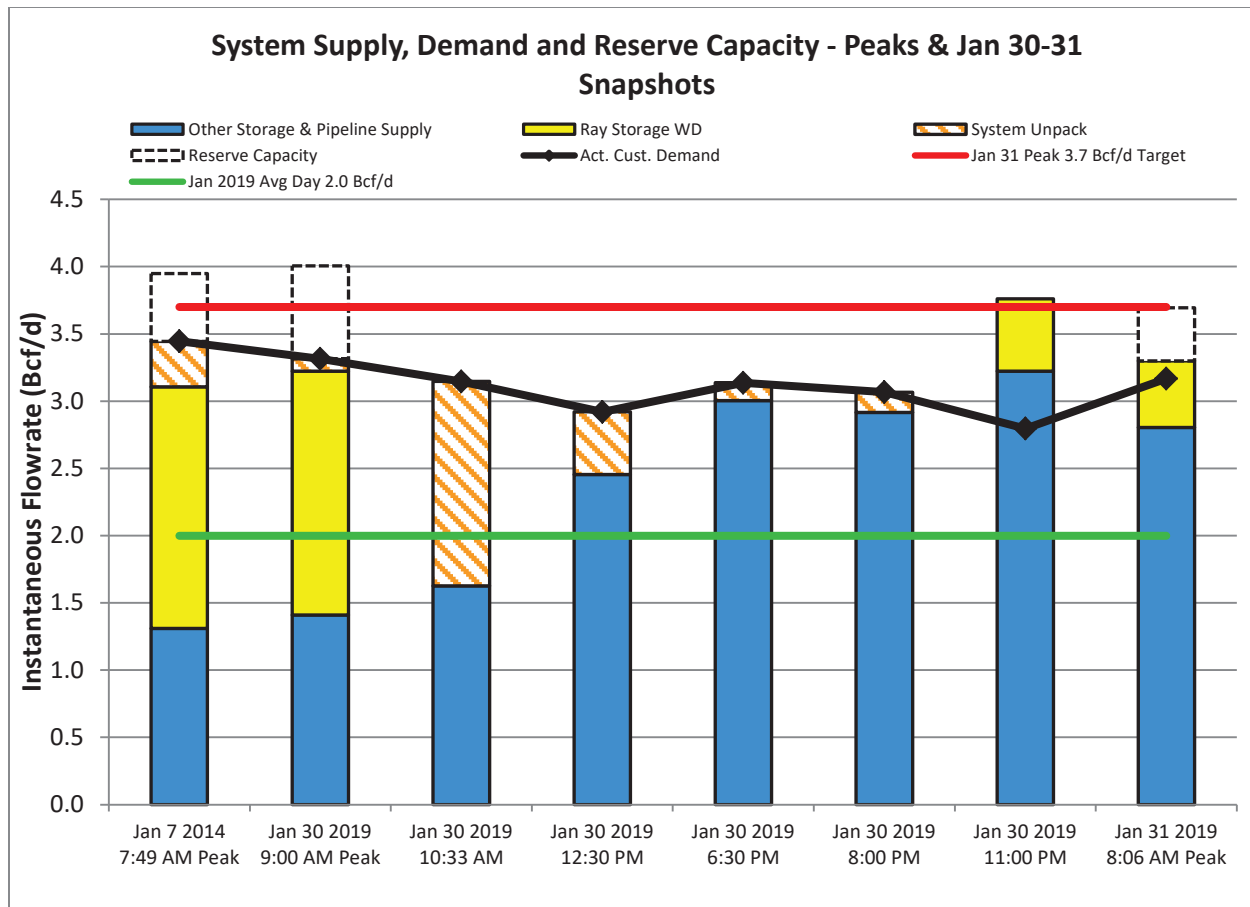
Figure 7. System supply, demand and reserve capacity

The system was operating according to plan until 10:28³ a.m. on Jan. 30 when Gas Control received a Ray Plant 2 fire-gate alarm and the instantaneous rate at Ray reduced from approximately 1,800 MMcf/day (1.8 Bcf/day) to zero. Due to the alarm, the first response to the restriction on access to our natural gas supply began in our Gas Control Center. Gas Control notified leadership and the appropriate operations personnel at approximately 10:30 a.m. As shown in Figure 7, the loss of Ray flow caused the system to begin unpacking at an excessive rate. Unpacking means the amount of gas and the available pressure in the pipeline system are decreasing. Unpacking occurs when the rate of total system supplies is lower than the rate of total deliveries to customers. Figure 7 depicts the status of system supply, demand, rate of system unpack, Ray Field flow prior to the fire-gate alarm through peak hour of Jan. 30 at 11:00 p.m. and the peak hour of the next day at 8:06 a.m. on Jan. 31. The loss of Ray and the rate at which the pipeline system was unpacking caused key system pressures to decline at excessive rates.

Throughout the day on Jan. 30, we completed periodic system assessments based on the conditions depicted in Figure 7. Demand through the period continued in line with projections near or above the

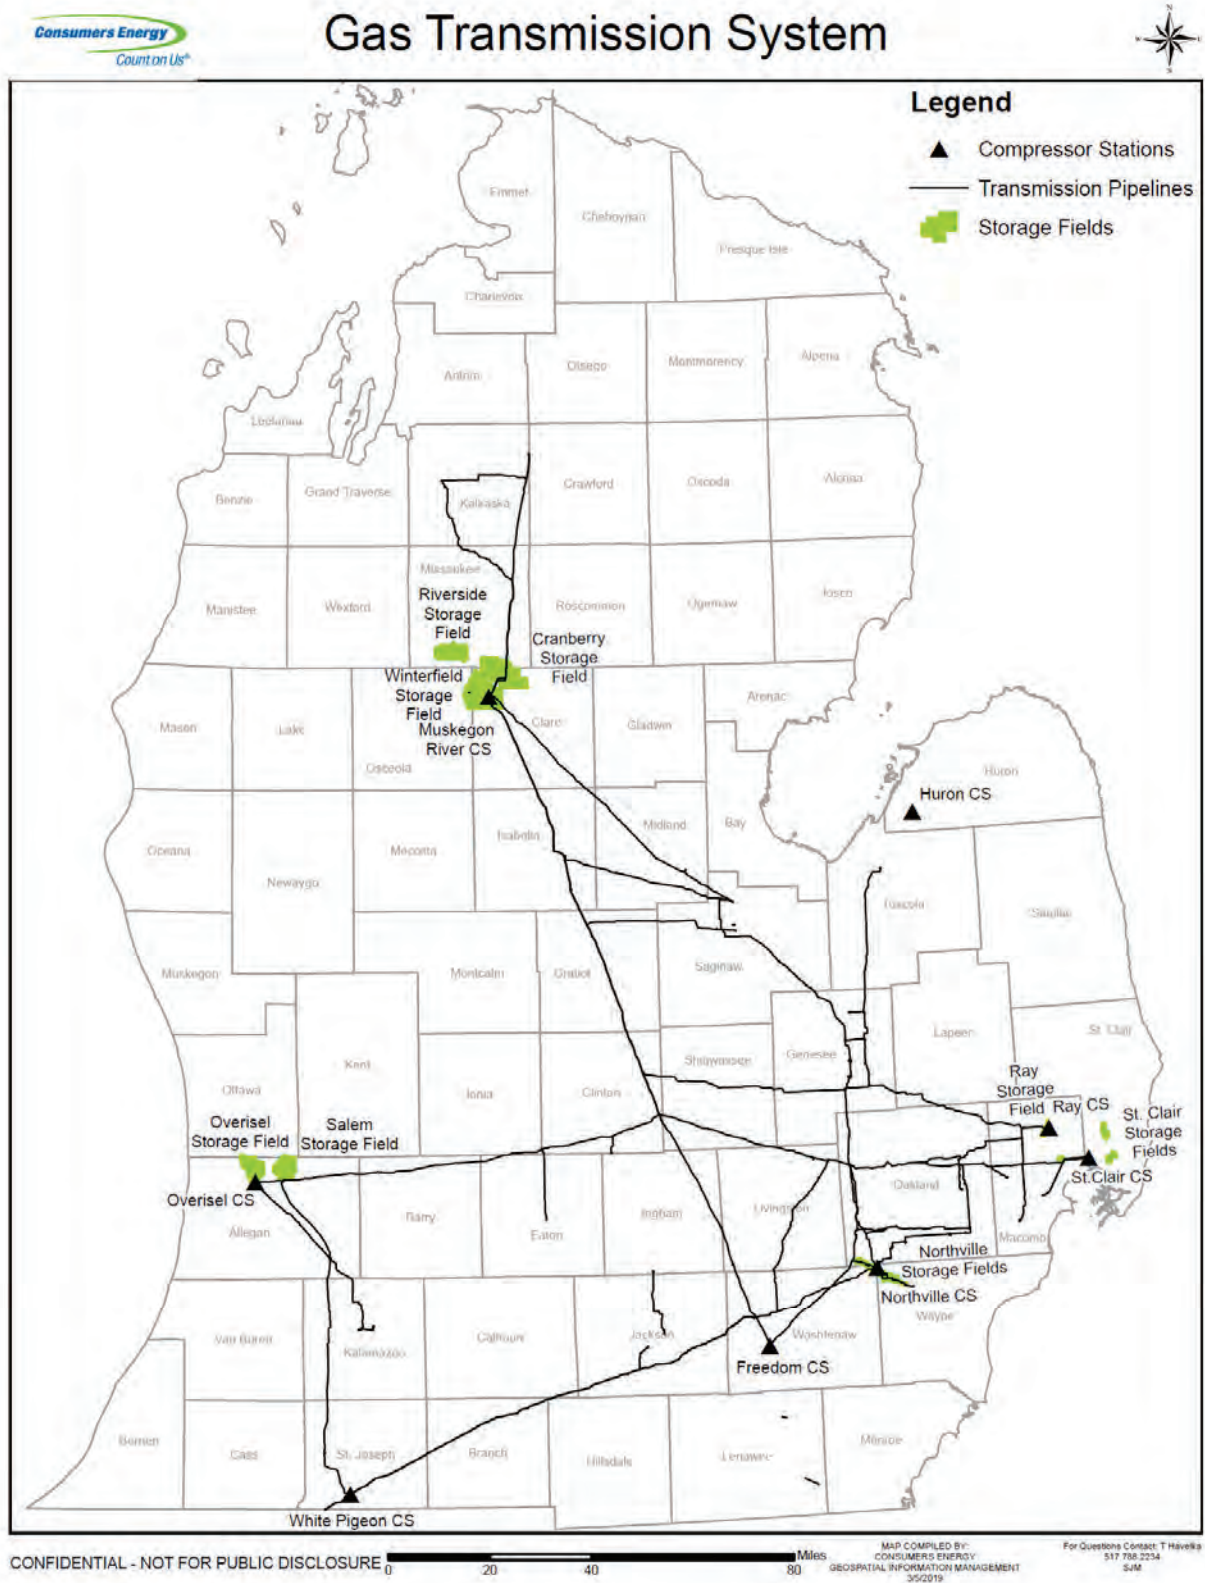
Figure 8. Map of Consumers Energy compression stations and storage fields

Shortly after the fire-gate alarm was received, Gas Control adjusted the storage field rate orders to dispatch all peaking storage fields at maximum flow rates including those fields on standby. The peaking storage fields dispatched at maximum rates included Lenox and Ira located in the St. Clair area and Lyon 34, Lyon 29 and the Northville Reef located in the Northville area. Lenox field, which received a dispatch order prior to the fire, began flowing and ramping up at about 9:15 a.m. The St. Clair, Northville and Ray storage areas are identified in Figure 8. The Northville Reef began flowing to system at 10:57 a.m. and Lyon 29 and Lyon 34 began flowing to system at 11:30 a.m. Ira began flowing to the system at 12:46 p.m. The peaking storage fields added approximately 975 MMcf/day of supply to the system. The dispatch of the peaking fields maximized the total amount of storage supply delivered to the system and reduced the system unpack rate. This peaking capacity, however, was forecasted to decline by approximately 500 MMcf/day by the next morning's peak hour as field inventories depleted. We considered the peaker field flow reduction in the gas supply procurement decisions throughout the day. As shown in Figure 7, the supply from the peaker fields significantly reduced the system unpack rate. It did not provide enough supply to begin repacking the system as demand remained relatively steady.

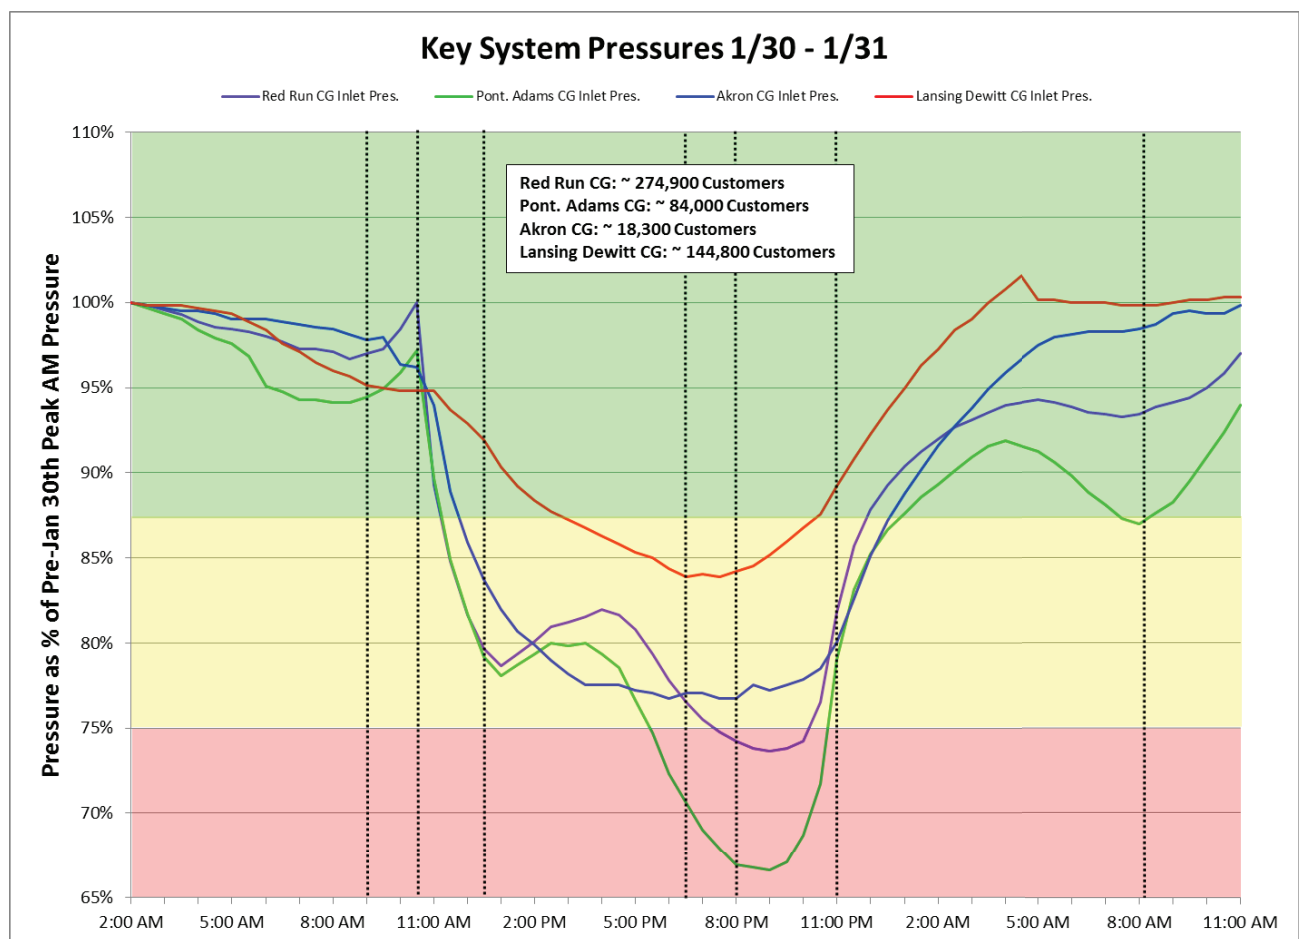
Figure 9. Gas pressure trends

From noon to 9:00 p.m. on Jan. 30, system pressures continued to drop and pipeline gas increased less than expected — possibly due to scheduling limitations and congestion in upstream pipeline systems. Industrial load reduction was not occurring as quickly as hoped, and load was growing from below 3 Bcf/day to over 3 Bcf/day in hourly flow rates. Given the adverse pressure trends shown in Figure 9, we worked with the SEOC and Gov. Whitmer's office around 8:00 p.m. to utilize the Emergency Broadcast System along with public appeals from CEO Patti Poppe and Gov. Whitmer to ask residential customers to help reduce natural gas usage.

- Page 16 of Consumers’ report states in part that “Given the adverse pressure trends shown in Figure 9, we worked with the SEOC and Gov. Whitmer’s office around 8:00 p.m. to utilize the Emergency Broadcast System along with public appeals from CEO Patti Poppe and Gov. Whitmer to ask residential customers to help reduce natural gas usage.”

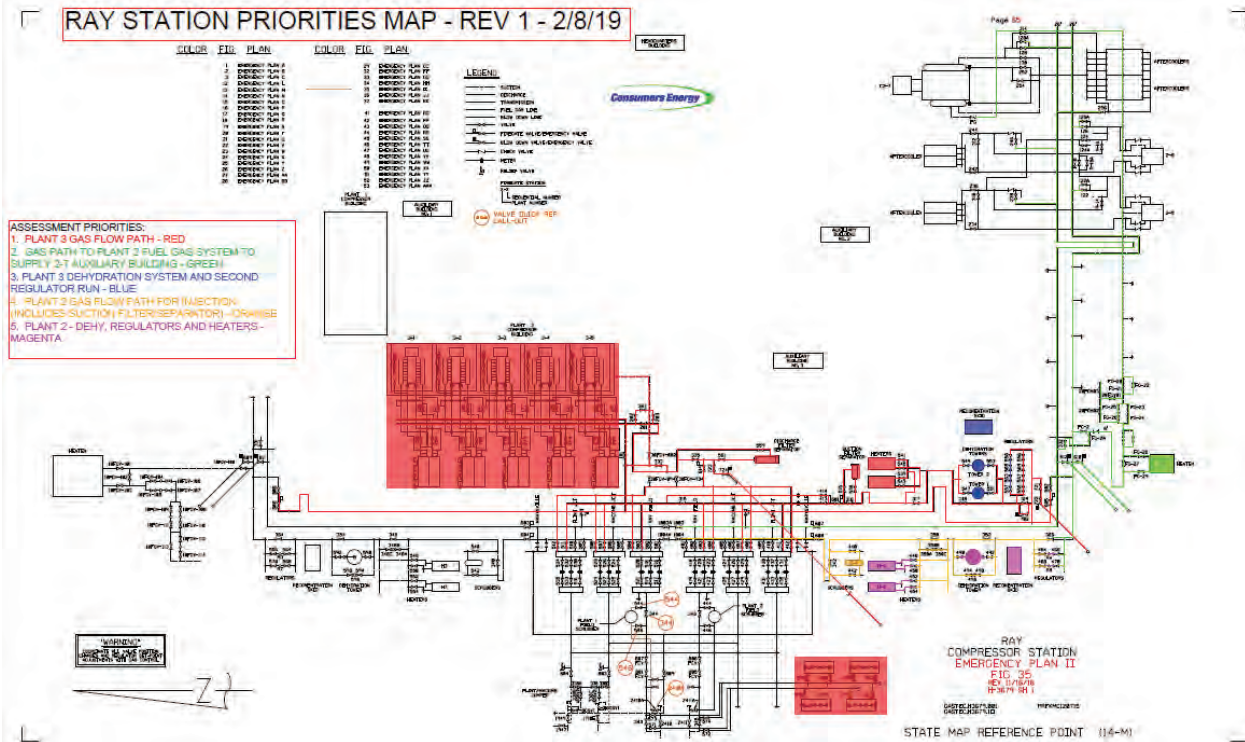
Figure 2. Ray Compressor Station Repair Priorities, illustrated

The repair prioritization process reflects the order of operations necessary to ensure customer needs can be met safely and reliably during the coming heating season. With this in mind, the Company determined that it would be most important to repair the injection equipment first, so that the natural gas storage field could be filled in preparation for the repaired withdrawal equipment to return to service before winter. Repair activity would then focus on returning the Plant 2 backup generator to operation, before addressing the extensively damaged dehydration equipment and, finally, any damage to buildings on site.
