May 2, 2022

RE: In the matter on the Commission's own motion of the investigation into the  
response of the DTE Electric Company to recent storm damage service  
territory  
Case No: U-20169

**Report of DTE Electric Pursuant to the MPSC's Order in Case No. U-20169**

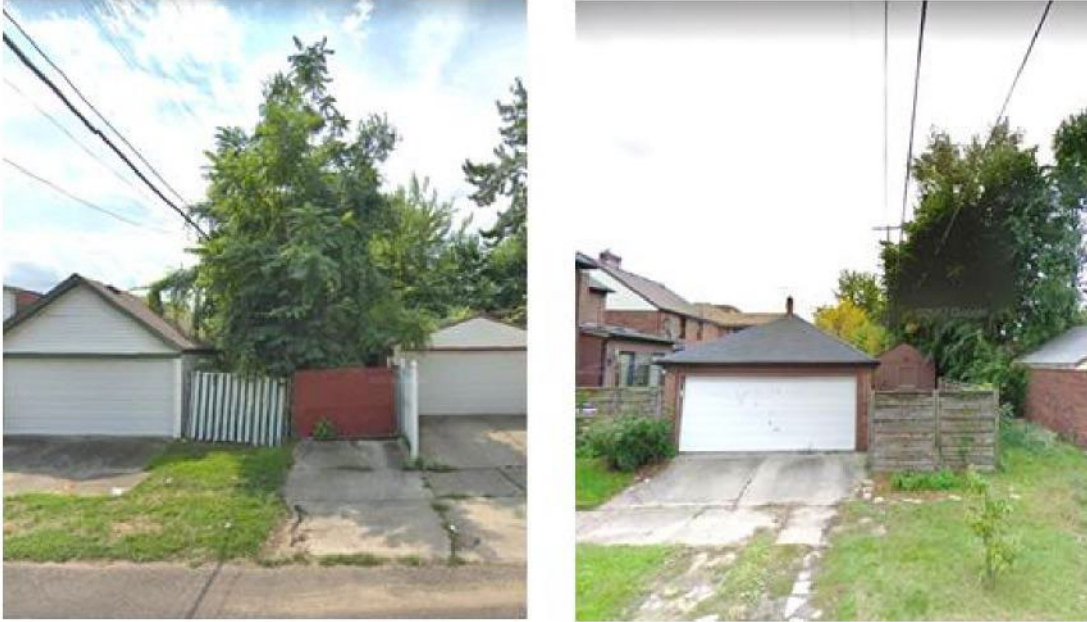
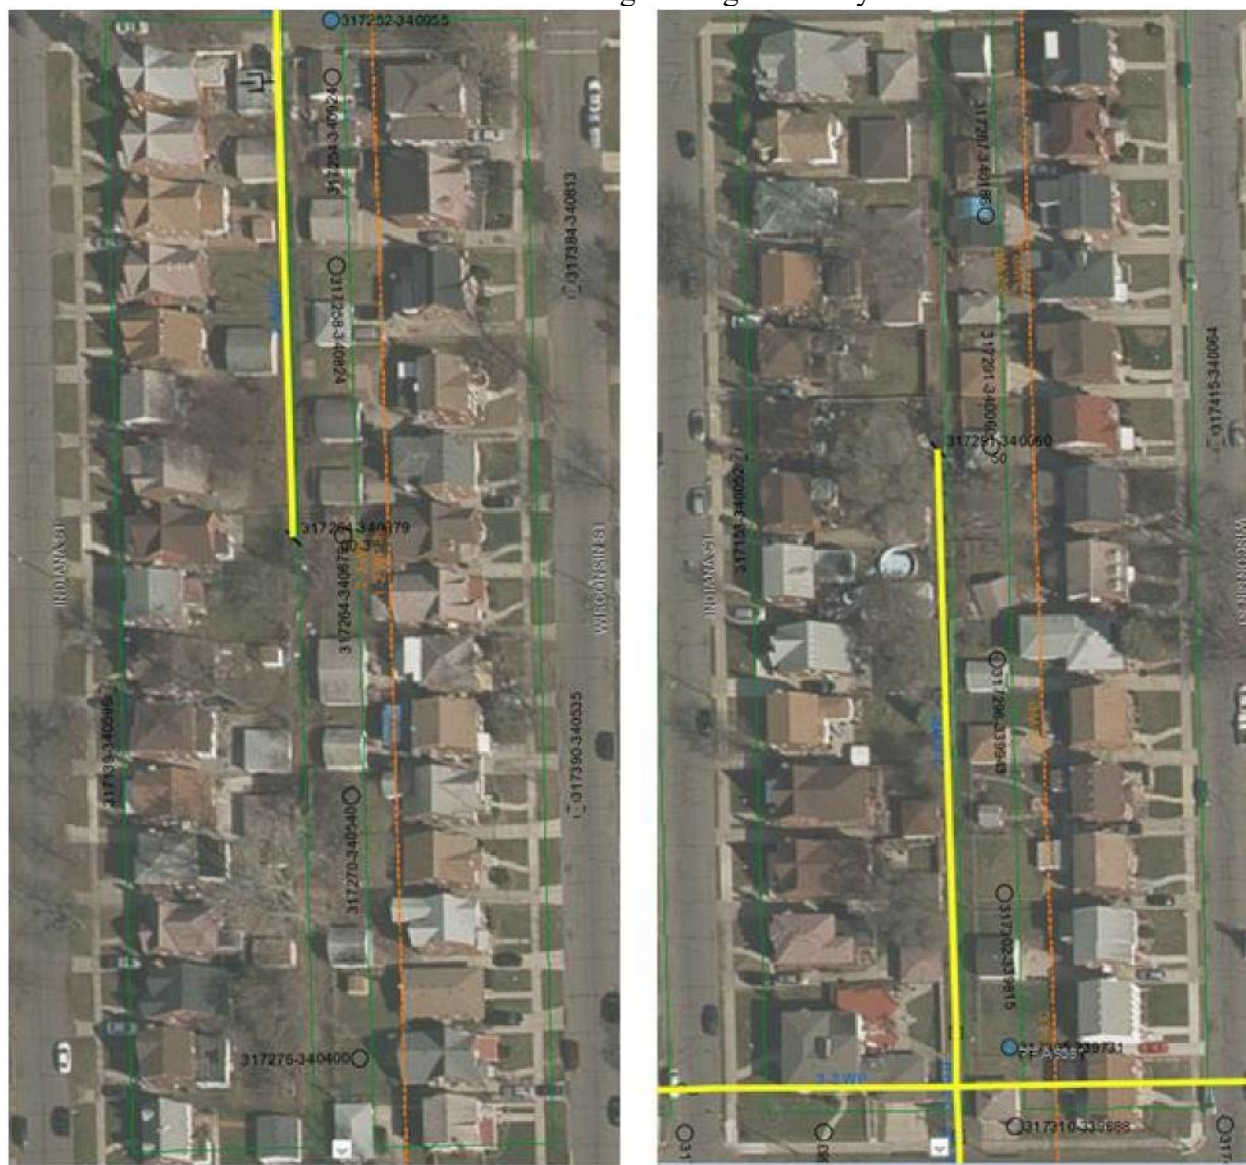
**Figure 10 - Appoline 1346 Pilot: Fence and Structure Encroachment in Right-Of-Way**

## Green Lines – Edge of Right-of-Way

Preliminary field visits and design were undertaken in the first quarter of 2019. In July 2019, a letter was sent to affected customers to inform them that DTE Electric will be working in the area. There exist encroachments of customers' fences and structures in the vacated alleys that require customer approvals before construction work can take place. The underground work will include trenching and boring and siting the pad mount transformers. Customers' meter boxes will have to be modified or replaced to accommodate underground service. Construction of the cable poles was completed in late 2019 and the URD loop construction was completed in the first quarter of 2020. The remaining work is the installation and connection of the underground service to the residences. This requires direct interaction with each customer, which was delayed in 2020 due to restrictions stemming from the COVID-19 pandemic. As of the end of 2021, approximately half of the customers have been transferred to the URD loop. Obtaining the required customer approvals to perform the work needed on their properties remains a challenge. The Company is going door to

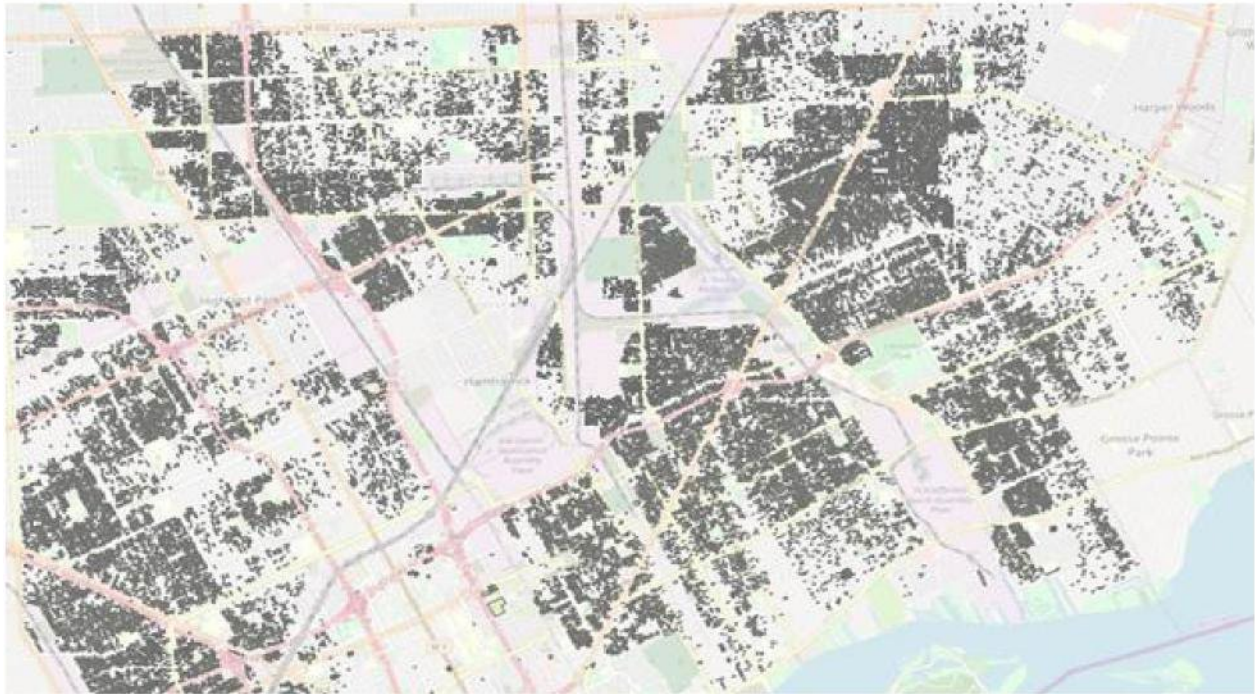
(east side of the Detroit Metropolitan area)

The blackened areas represent unoccupied properties

In these sparsely populated areas, primary de-conductoring may be an option. Primary de-conductoring involves the removal of small sized primary wire and arc circuit wire as well as overhead transformers and pole tops, and reconductoring secondary wires where necessary. The amount of infrastructure removal is dependent upon the sparsity and location of customers in the neighborhood while maintaining adequate voltage on the secondary (in absence of the primary) and jumpering points for contingencies. Two circuits were selected for the pilot: Wayburn 2136 and Grant 1598. Combined, the two circuits serve 1,300 customers and have 19 miles overhead primary, or 68 customers per overhead mile of primary – sparse for an urban neighborhood.

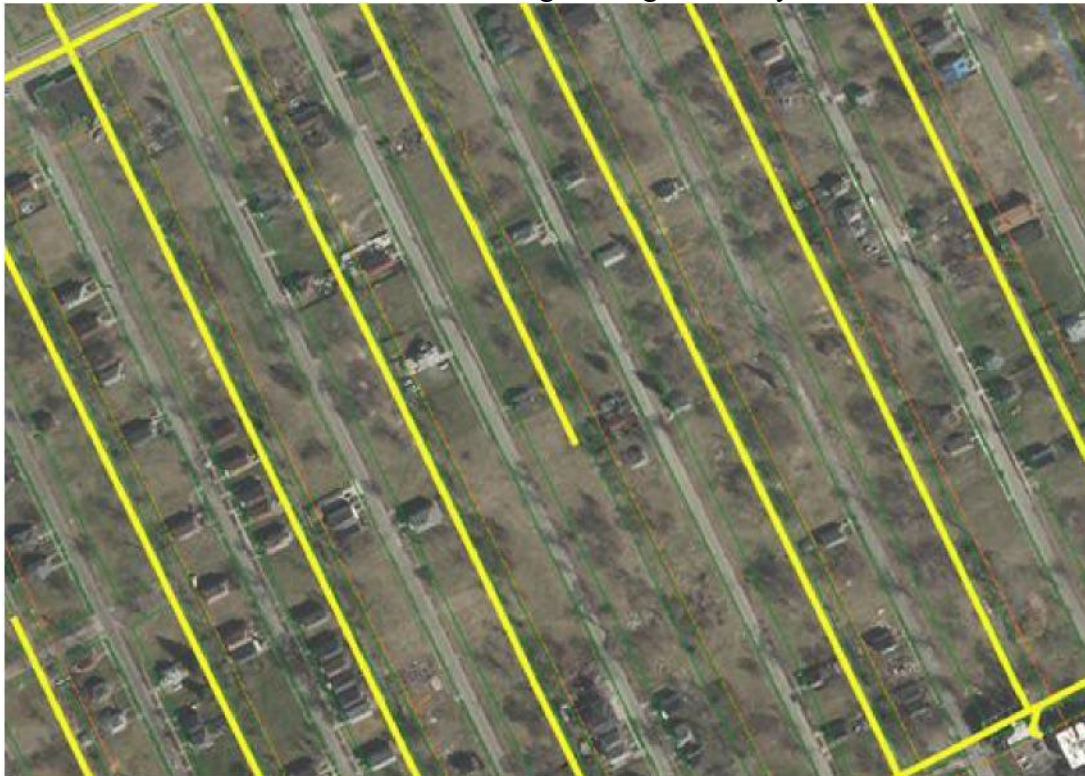
Red Lines – Secondary Conductors

Green Lines – Edge of Right-of-Way

High level conceptual design and scope of work have been completed for both circuits. The combined scope includes the removal of 40,000 feet of primary, removal of 120 rear lot overhead transformers, installation of 60 truck accessible transformers, and reconductoring 20,000 feet of secondary. After completion of the pilot, based on lessons learned and costs, an evaluation will be made as to the feasibility and economics of additional opportunities for primary de-conductoring.
